ADVANCED METALLIC AIR VEHICLE STRUCTURE PROGRAM Return to Grammer when emplele.

SIXTH INTERIM REPORT

GENERAL DYNAMICS FORT WORTH DIVISION

TECHNICAL REPORT AFFDL-TR-76-74

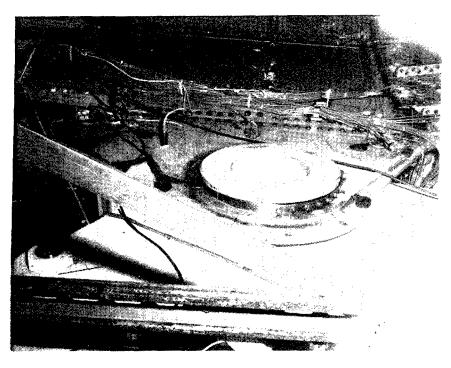
FIGURE 2.1.1-1

RETENTION OF UPPER BUSHING TO PIVOT PIN

Special wrenching mechanisms were designed to realign the pivot pins and lug bushings which rotated during the early stage of testing. Retaining systems were also designed to prevent recurrence of the rotation problem (See Figures 2.1.1-1 and 2.1.1-2). Repair procedures, hardware, tools, and supplies were planned and coordinated for replacement of broken fasteners, restoration of the pivot system, and retention of bolts experiencing repeated loosening.

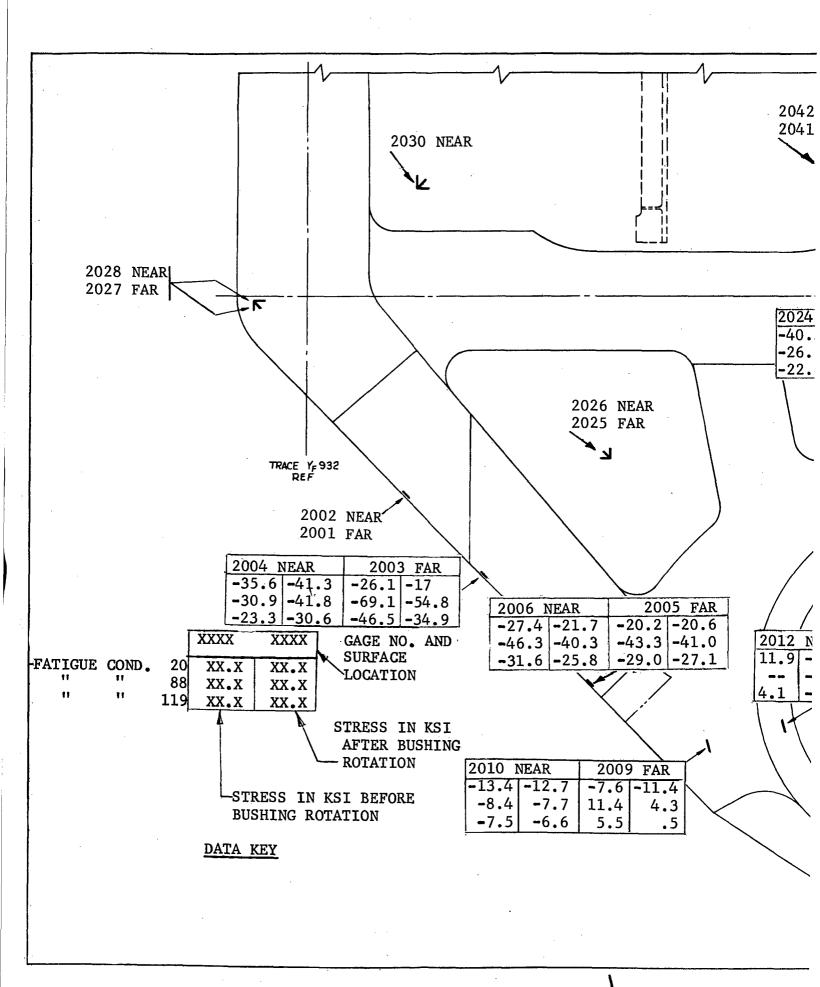
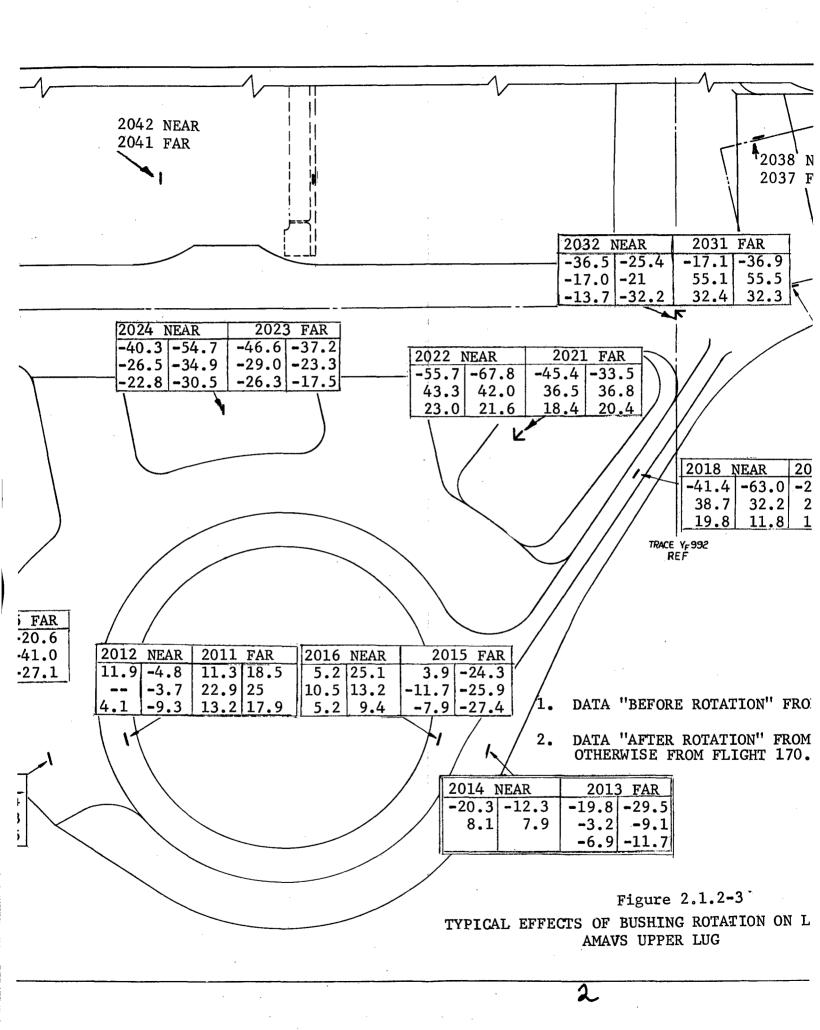
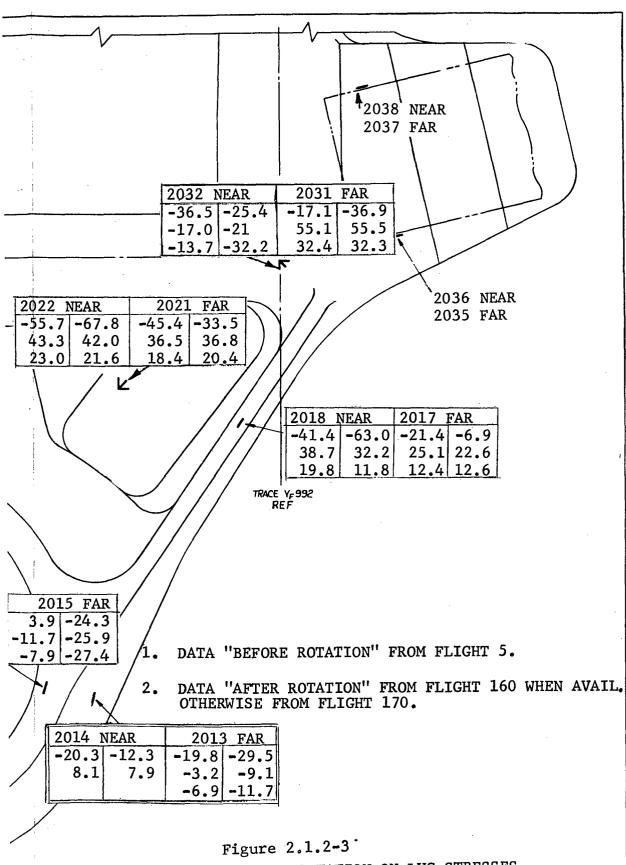
TYPICAL EFFECTS OF BUSHING ROTATION ON LUG STRESSES

AMAVS UPPER LUG

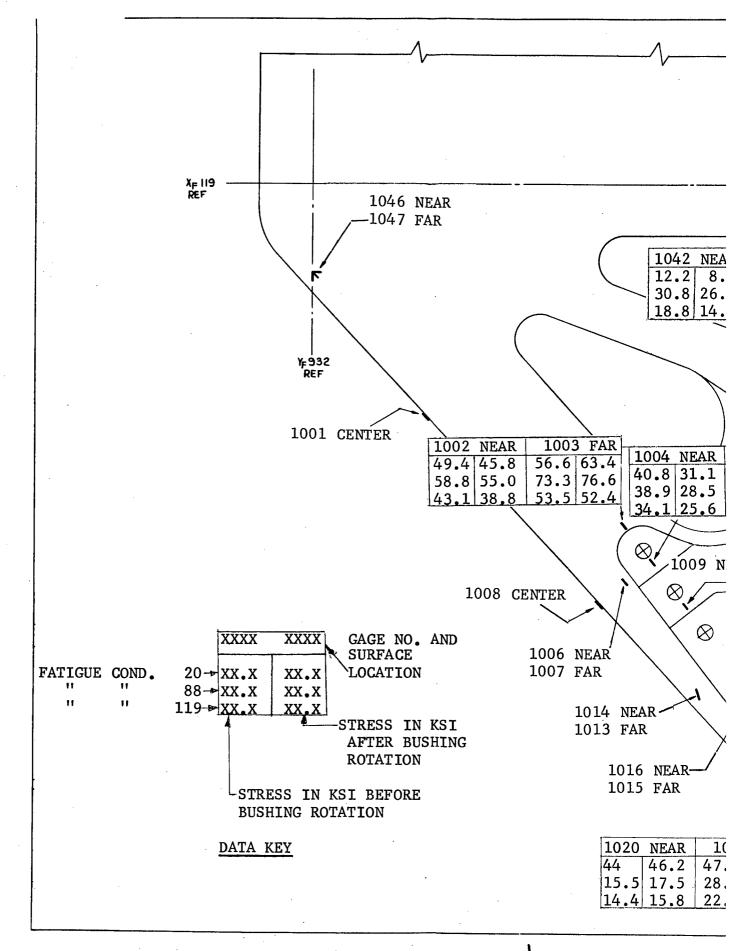
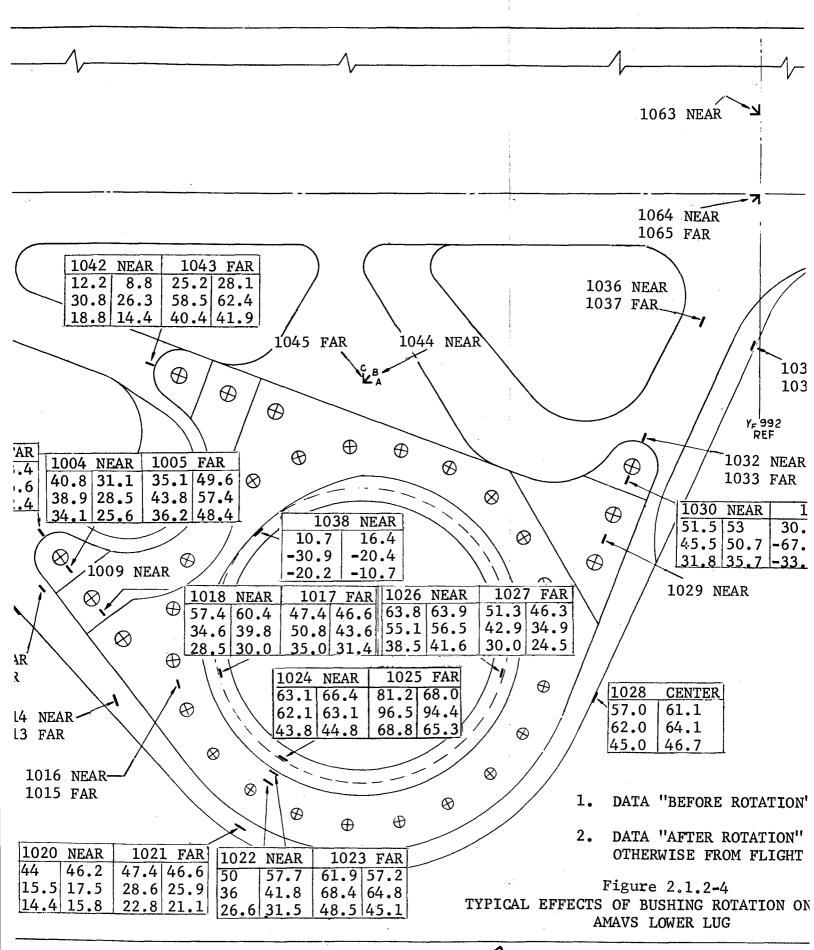
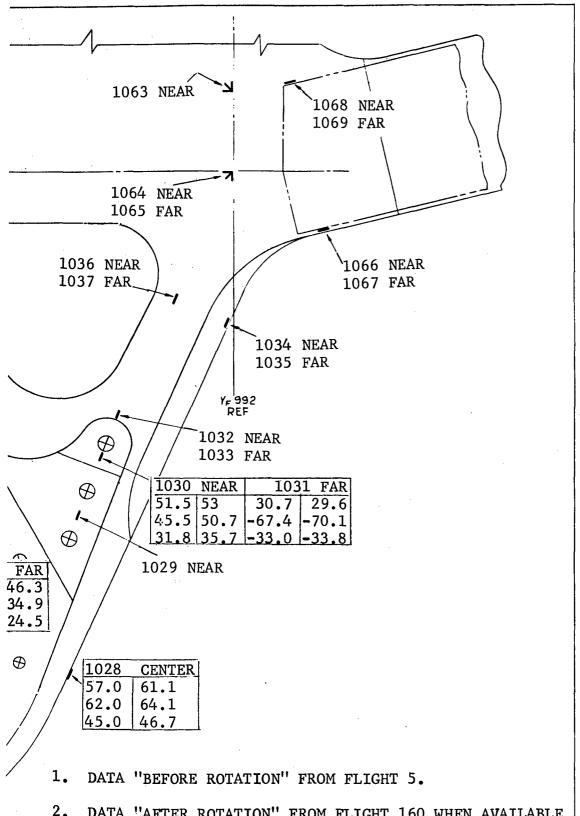
Figure 2.1.2-4
EFFECTS OF BUSHING ROTATION ON LUG STRESSES
AMAVS LOWER LUG

2. DATA "AFTER ROTATION" FROM FLIGHT 160 WHEN AVAILABLE. OTHERWISE FROM FLIGHT 170.

However, the stress changes under load were considered to be indications that the obvious wedging caused by bushing rotation could adversely affect the fatigue life because of possible stress increases.
